MVV Environment Baldovie Ltd's planned autumn shutdown has just concluded on time. Much work was completed during the 21 day outage.

Major refurbishment works were carried out along with other routine tasks. The highlights of this are below:

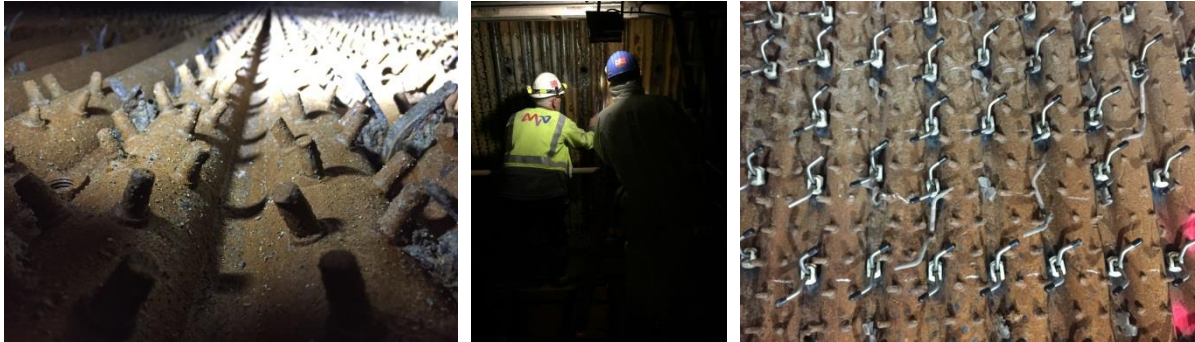
Figure 1 - Boiler tubes after hydro demolition, MVV staff inspecting tubes and new refractory anchors in place ready to be coated.

- Refractory on both furnaces lower walls was removed by ultra-high pressure water jetting, new anchors were installed to hold the refractory and a new coating of refractory was applied.

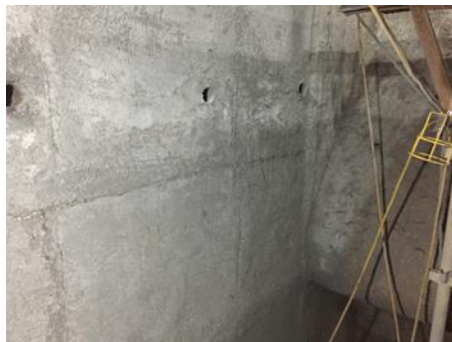
Figure 2 - New refractory (insulating layer) following application.

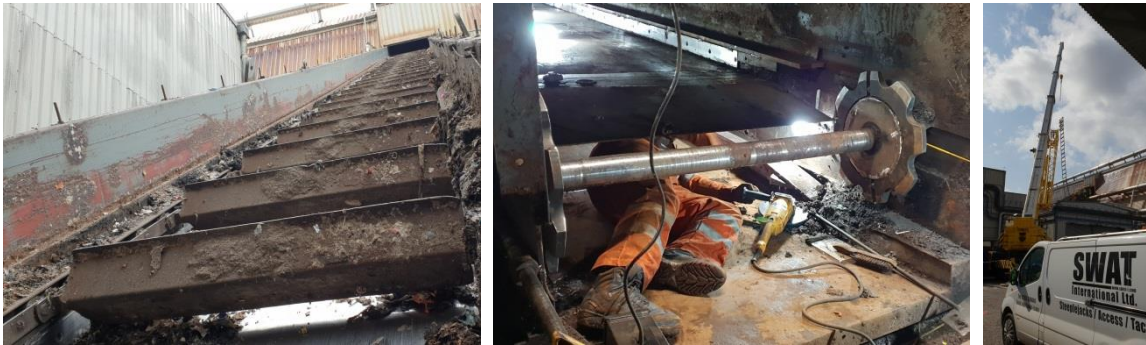
- The main chain conveyor which takes fuel to the fuel store was renewed. This conveyor chain had worn owing to the aggressive nature of the material it transports. The new chain installed should last a minimum of eighteen months.

Figure 3 - Worn chain, work inside the conveyor and new chain being installed.

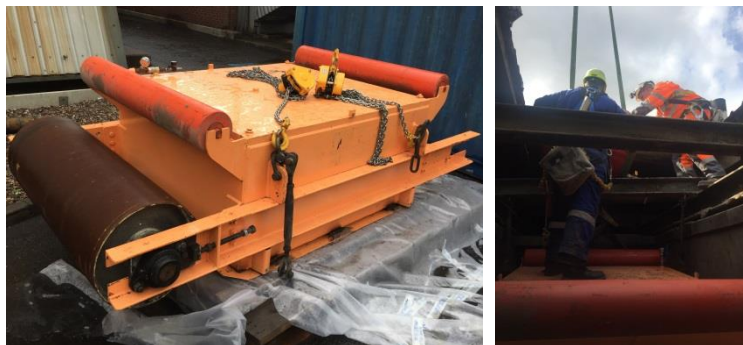
Figure 5 - Magnet reinstallation

- Hammermill one's rotor (which weighs eleven tonnes) was replaced with a rotor which had been refurbished by a local engineering and fabrication company.
- The unserviceable secondary electromagnet which increases the removal efficiency for ferrous metals from 85% to 98% (in comparison to a single stage process) was removed from the top of the building, overhauled by a workshop in Falkirk and then reinstalled.

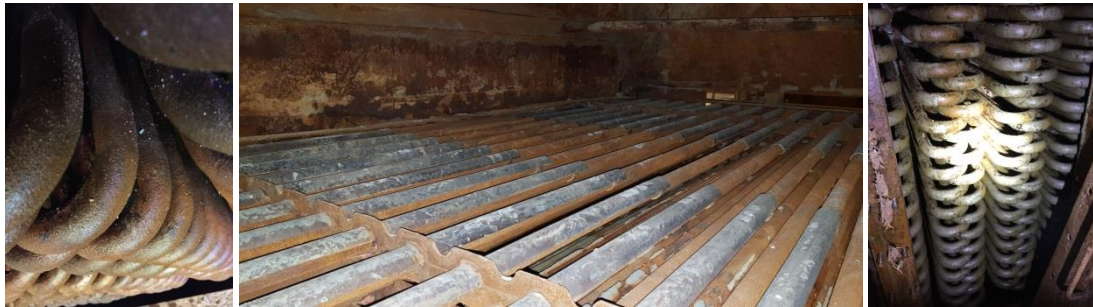
- The economiser banks which are used to preheat the water before it enters the furnace were thoroughly cleaned by high pressure water jetting and inspected for any wear. Any weak areas found were repaired.

Figure 6 - Heat exchanger bundles after cleaning

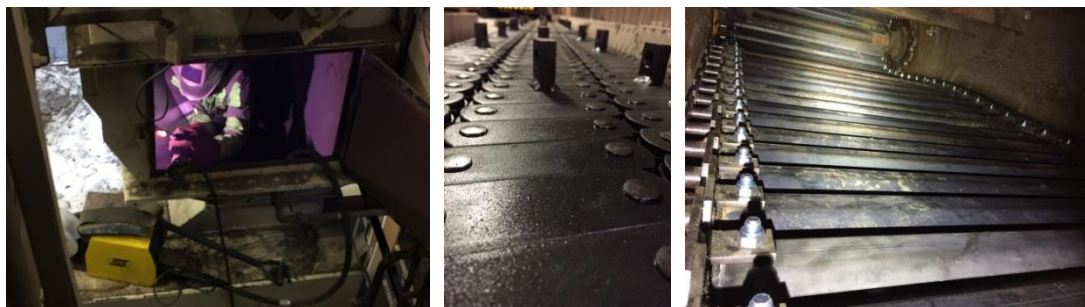
- Internal fuel conveyors had their wear parts replaced to ensure continued operation. In a plant which runs twenty four hours a day, seven days a week it is essential to maintain and replace wear parts such as chains to avoid costly downtime at a later date.

Figure 8 – MVV fitter welding a feed hopper, new chain before installation and an internal fuel conveyor with wear parts replaced.

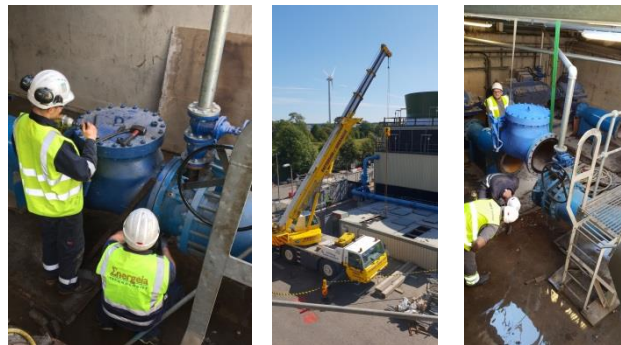
Figure 9 - (from left to right) Valve removal followed by reinstallation

- Both cooling water non-return valves were removed and overhauled off site by a company based in Inverkeithing before being craned back in.

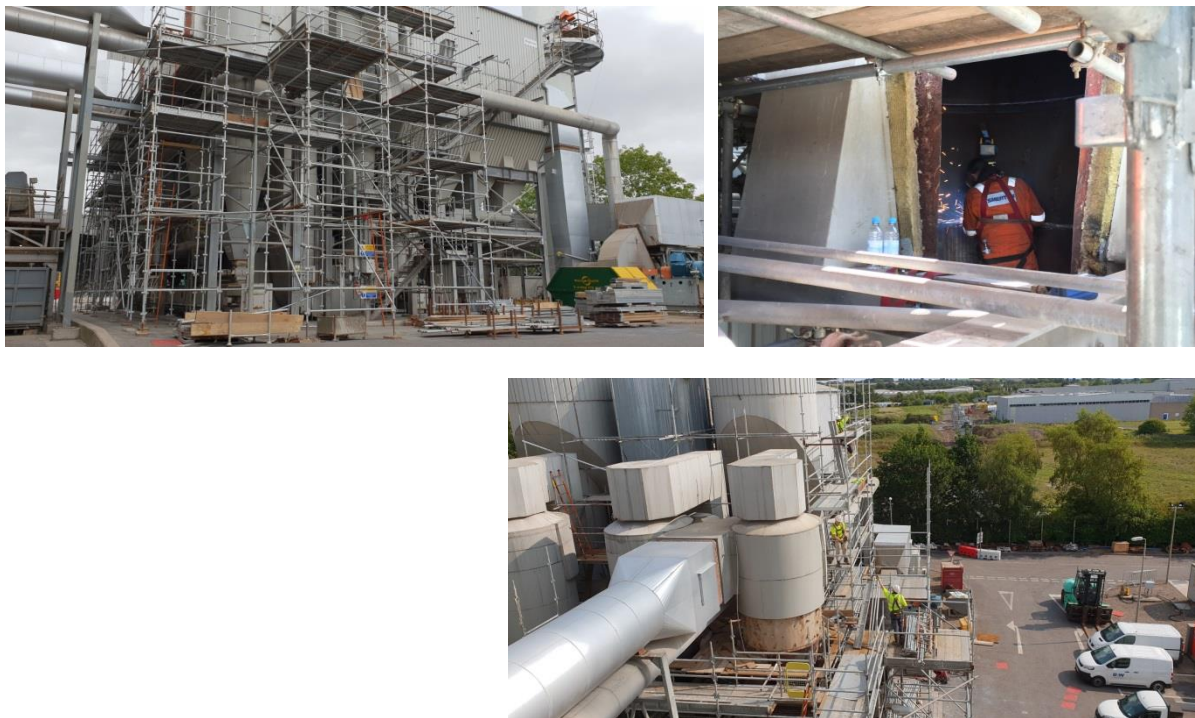
- The flue gas treatment plant was thoroughly inspected and any weak areas were replaced.

Figure 10 - Access to and upgrade of the flue gas treatment plant

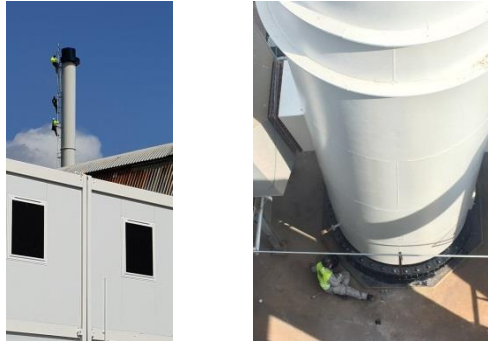
- Both stacks were inspected by steeplejacks and some minor painting works were carried out at both the top and base. This ensures there is no corrosion and that the lightning conductors and earths are in good order to ensure they are in a good state to operate for another twelve months.

Figure 11 - Steeplejacks inspecting and painting a stack

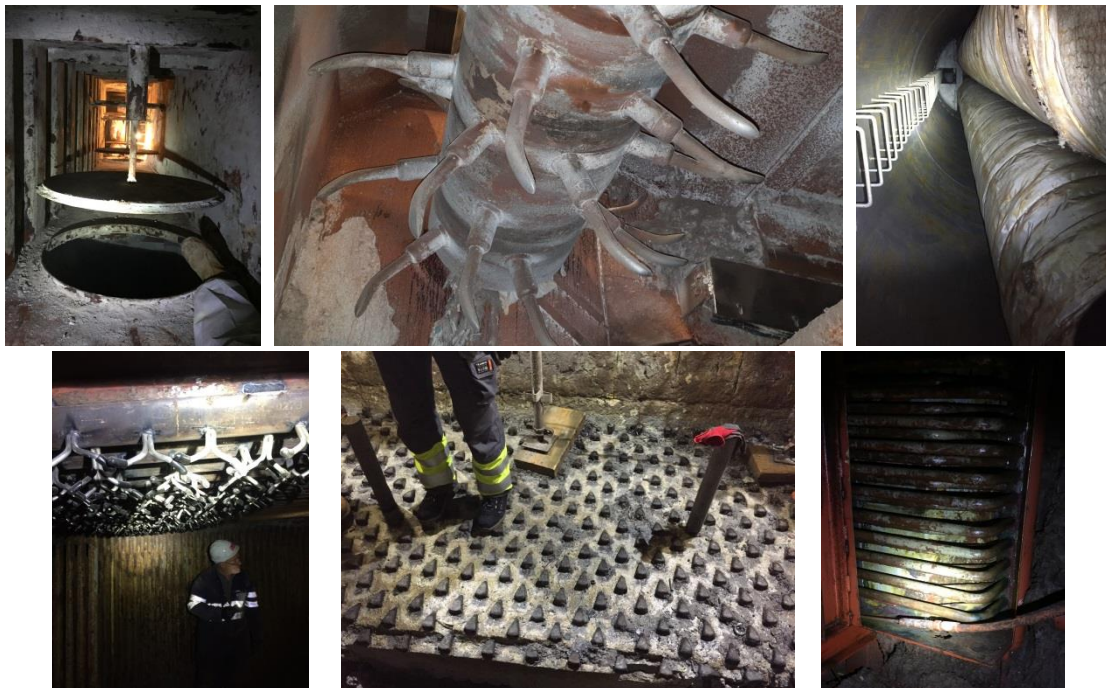
- Areas of plant not accessible during normal operation were inspected by MVV staff and contractors to ensure they were in a condition suitable for continued operation. Some of these as can be seen in the below photograph are very small to fit into or need other parts of the plant removed to gain access.

Figure 12 - Plant inspections
