**Figure 1 Photograph Looking Towards The Northern Part of The Site**

**Figure 2 Photograph of Southern Part of Site Looking North West**

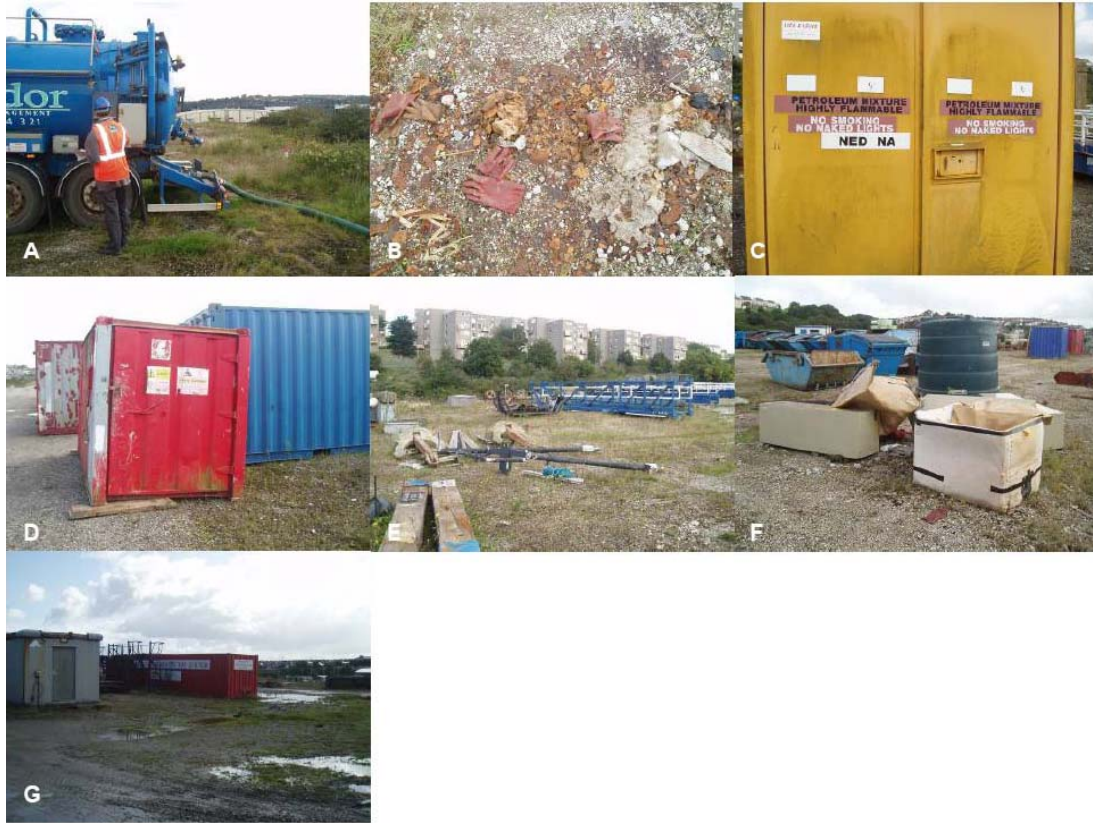
**Figure 3 Collection of Photographs Highlighting Potential Sources of Contamination**

(a) Waste tank which appears to have emptied its contents on site (b) rusting metal on the ground (c) and (d) containers which could potentially contain highly flammable liquids (e) and (f) general waste and scrap and (g) a container which housed a fire suppression system.

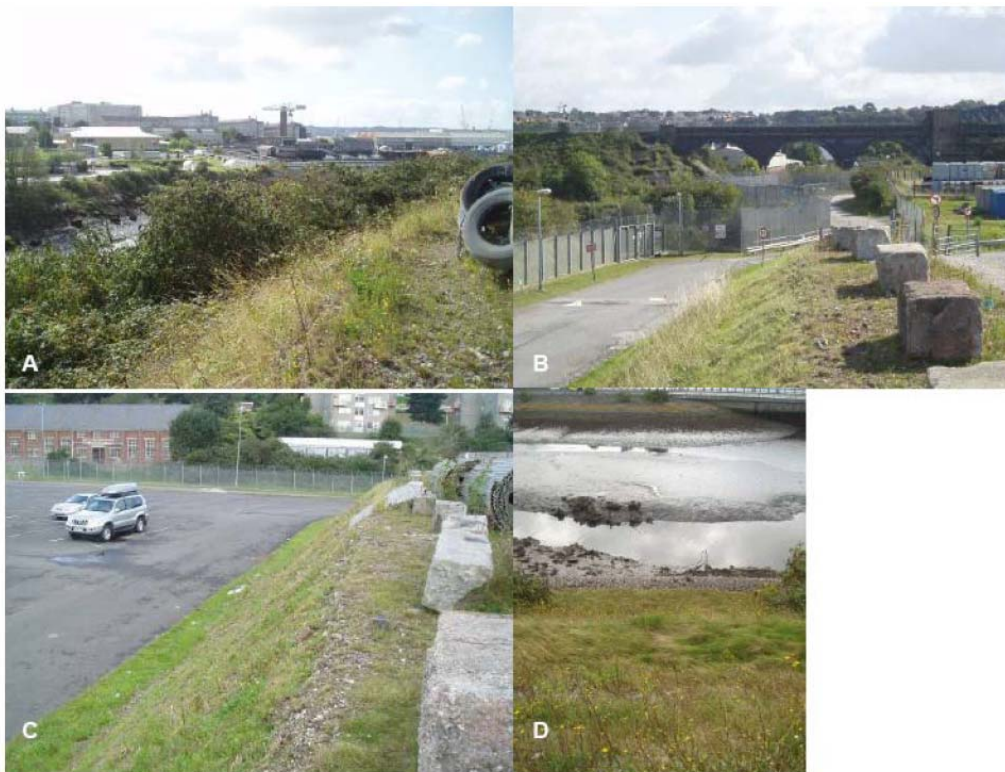
**Figure 4 Photographs of Embankment Slopes Around Mounded Southern Part of Site**

Figure 4: Photographs of embankment slopes around mounded southern part of the site (a) east-side (b) north-side (c) west-side (d) south-side

(a) east-side (b) north-side (c) west-side (d) south-side
