MVV Umwelt GmbH
Energy from Waste Combined Heat and
Power Facility
North Yard, Devonport
Tree Survey

October 2010

Tree Survey October 2010

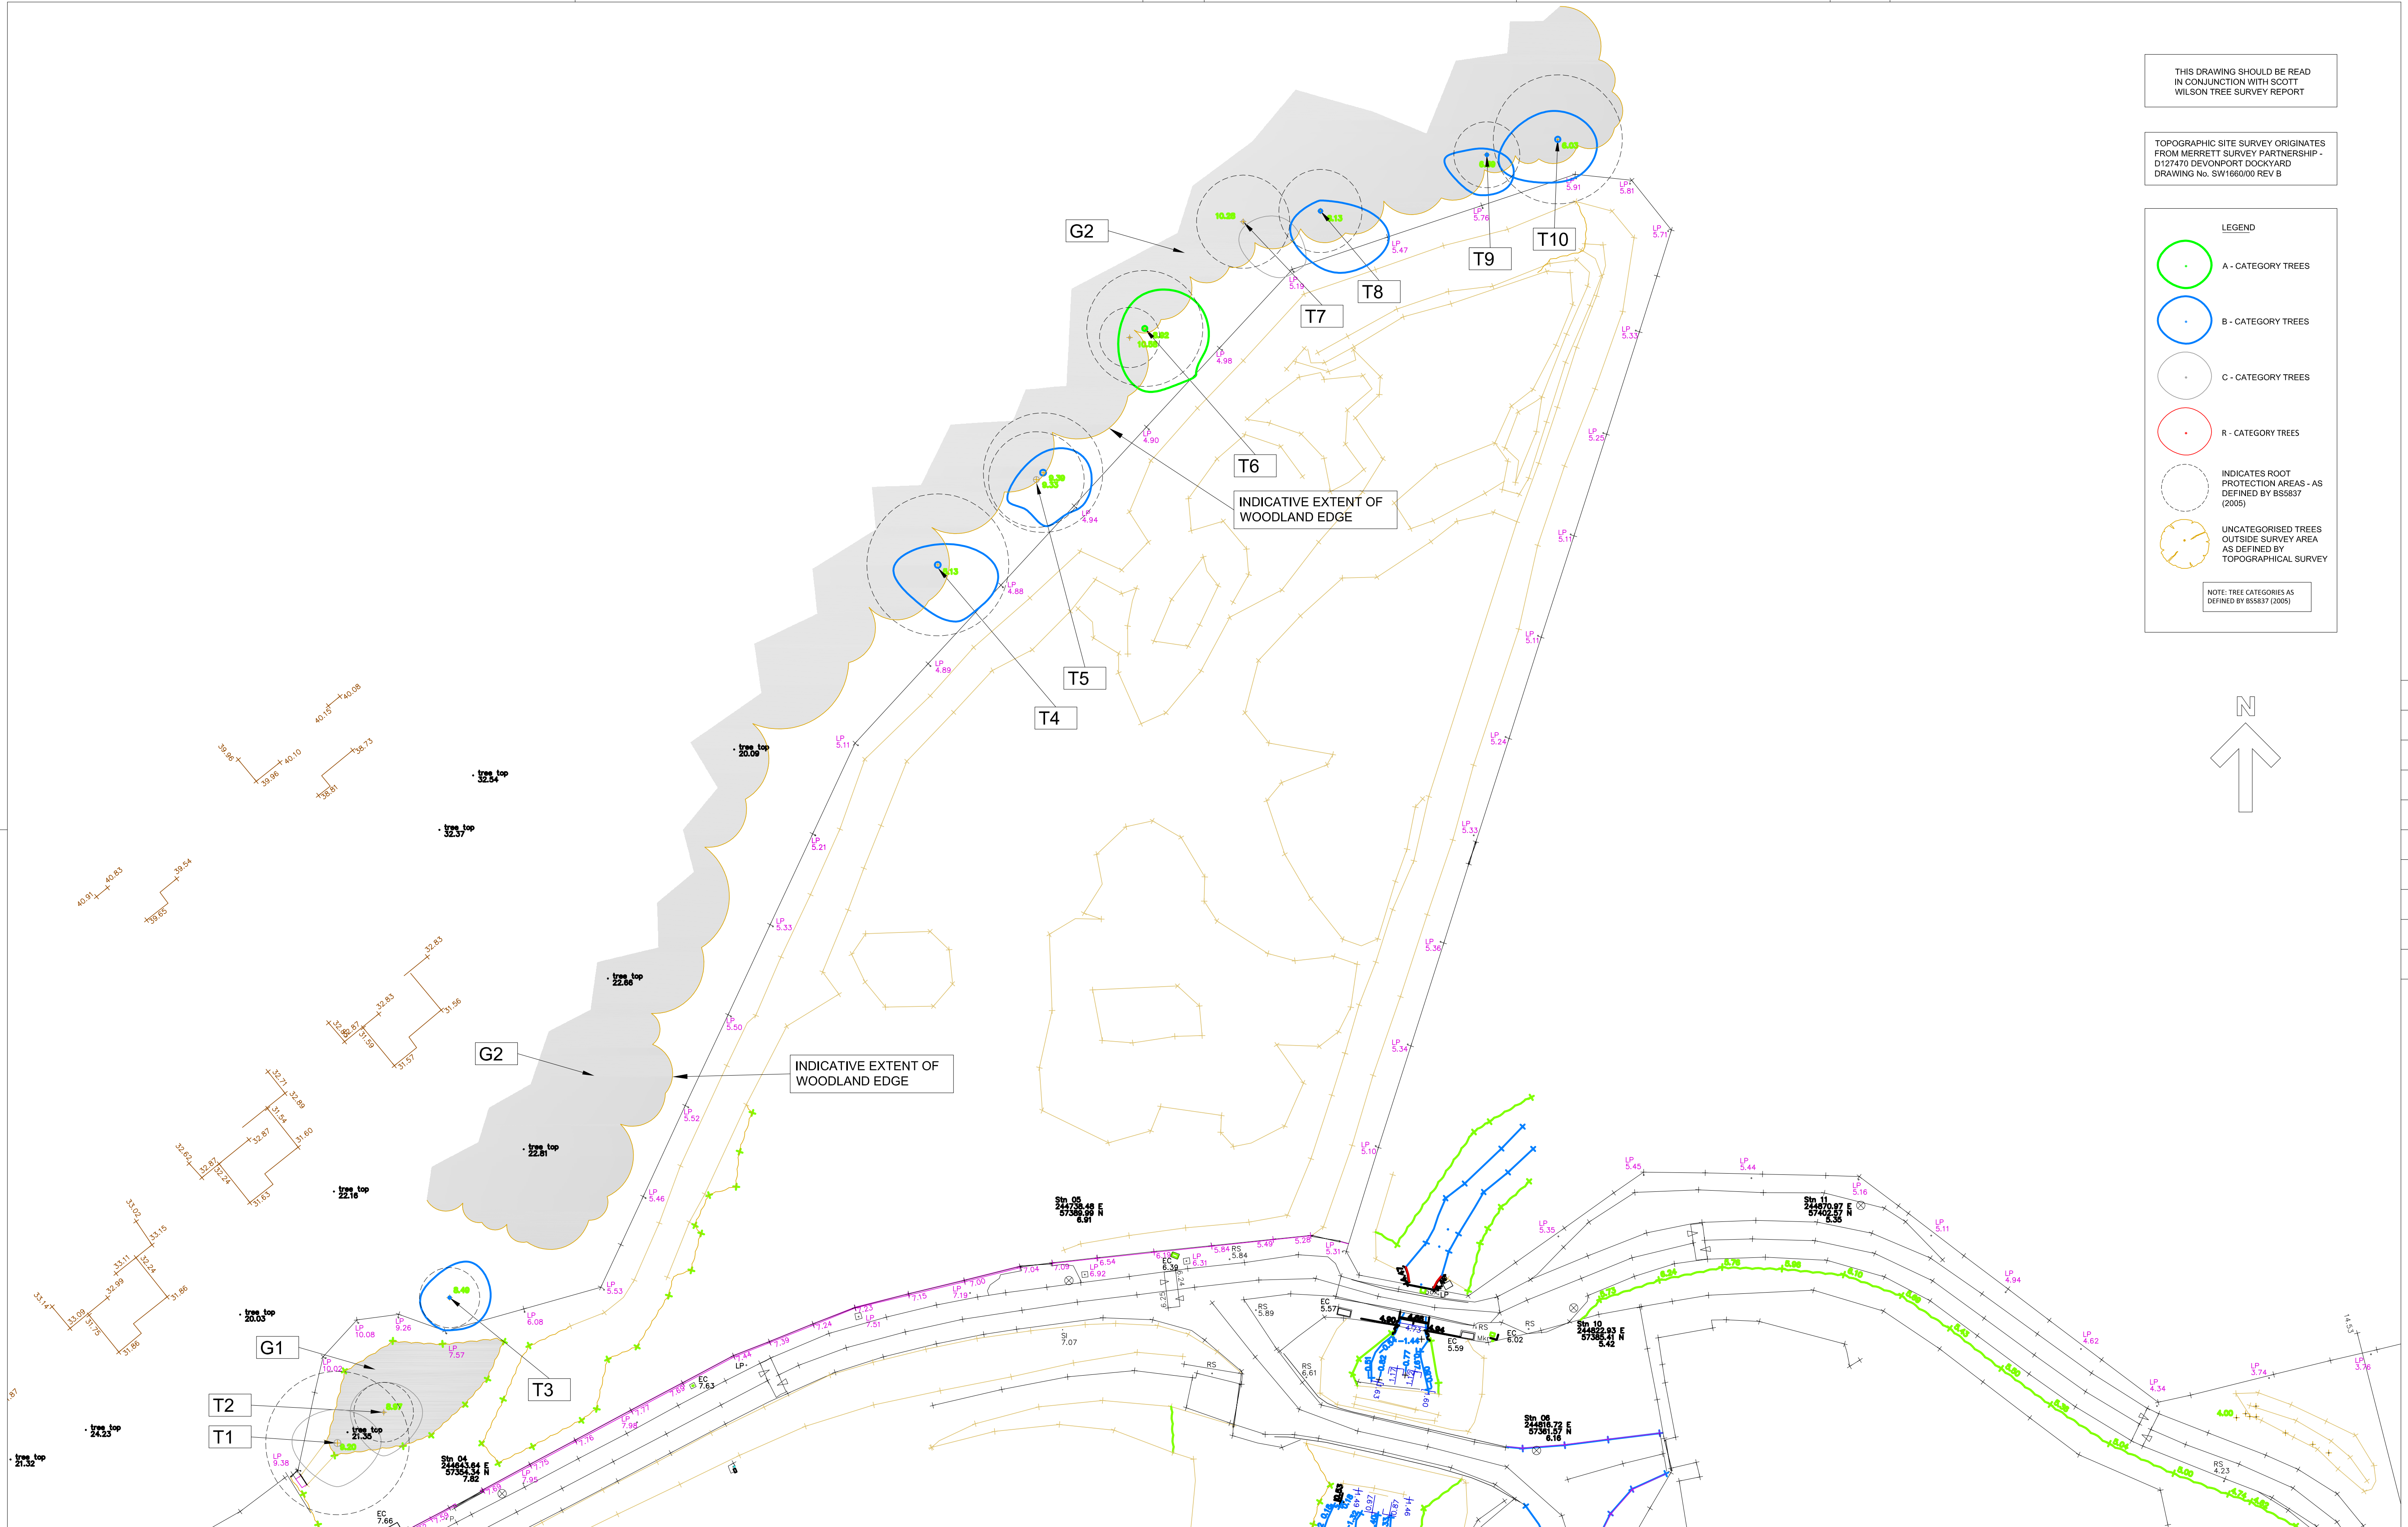
Ref. No	Species	Est. Height (m)	Stem Dia. (mm)	Canopy Spread (m)				Crown Clearance (m)	Physiological Condition	Age	Structural Condition	Preliminary Management Recommendations	Est. Remaining Contribution (yrs)	Cat.
				N	S	E	W							
T1	English Oak (<i>Quercus robur</i>)	12.0	1200 (Comprising 4No. x 360 stems)	5.6	7.3	7.3	7.6	0.0 (MS)	Fair	M	Four main trunks rising from base (and are presumably the same tree). Deadwood within canopy. Pruning wounds visible on SE edge with wound wood developing. Ivy cover to main trunk and limbs limits further inspection.	Of possible ecological value. Monitor pruning wounds to main trunk for decay. Remove dead wood only where this represents a Health and Safety hazard	20-40	C2
T2	English Oak (<i>Quercus robur</i>)	10.0	500*	5.0*	7.3	6.5	5.6	0.0 (MS)	Fair	M	Three main trunks rising up from low level and bias to SE. Ground levels appear to have been raised at base on S side. Dead wood visible within canopy including epicormic growth to main limbs. Low canopy tips on S side. To 1.0m Ht.	Of possible ecological value. Monitor pruning wounds for decay and general health re: levels increase at base. Remove dead wood only where this represents a Health and Safety hazard	10-20	C2

T3	English Oak (<i>Quercus robur</i>)	15.0	420	5.2	5.5	6.8	4.9	4.0	Fair/Good	M	Isolated tree within area of dense undergrowth. Of generally balanced form with minor deadwood within canopy. Ivy cover to main trunk and branches limits further inspection	Of amenity/ecological value to location. Sever Ivy and reassess. Sever/remove Ivy to lowest 1.0m of trunk and reassess. Remove dead wood only where this represents a Health and Safety hazard	40+	B2
T4	English Oak (<i>Quercus robur</i>)	15.0+	990	3.4	8.7	9.5	7.2	1.5	Fair/Good	M	Growing at base of bank on woodland edge and in competition with adjacent trees. Ivy becoming established on main trunk. Deadwood visible within canopy with occasional torn branch stubs and decay visible. Canopy bias and leaning to SE due to competition with adjacent trees. Long lateral limbs extending towards site.	Of amenity/ecological value as part of woodland group. Sever/remove Ivy to lowest 1.0m of trunk and reassess.	40+	B2

T5	English Oak (<i>Quercus robur</i>)	12.0	E=1000* W=800*	3.4	8.8	8.0	3.9	E=0.5 (MS) W=1.0 (MS)	Fair	M	Growing on bank area on woodland edge and in competition with adjacent trees. Canopy bias to SE with long lateral limbs extending towards site. Base of tree being slowly undermined by erosion of bank	Of amenity/ecological value as part of woodland group. Monitor bank erosion/tree stability. Consider reduction of long, lateral limbs to re-balance. Sever/remove Ivy to lowest 1.0m of trunk and reassess	20-40	E=B2 W=C2
T6	English Oak (<i>Quercus robur</i>)	15.0+	E=810 W=420*	5.8	10.5	10.6	4.1	5.0	E=Fair/Good W=Fair	M	Growing on bank area on woodland edge and in competition with adjacent trees. Canopy bias to SE with long lateral limbs extending towards site. Deadwood within canopy. Large buttress roots exposed where soil has been progressively eroded from bank. Ivy becoming established on main trunk	Of amenity/ecological value as part of woodland group. Sever/remove Ivy to lowest 1.0m of trunk and reassess. Remove dead wood only where this represents a Health and Safety hazard. Assess stability and consider reduction of long, lateral limbs to re-balance	E=40+ W=20-40	E=A2 W=C2

T7	English Oak (<i>Quercus robur</i>)	12.0	650*	0.0	0.0	7.7	5.2	4.0	Fair	M	Growing on bank area on woodland edge and in competition with adjacent trees. Main trunk emerges from bank horizontally before log-logging vertically at 3.0m. Long lateral limbs extending towards site. Deadwood within canopy. Ivy becoming established on main trunk	Of ecological value as part of woodland group. Sever/remove Ivy to lowest 1.0m of trunk and reassess. Remove dead wood only where this represents a Health and Safety hazard. Assess stability and consider reduction of long, lateral limbs to re-balance	20-40	C2

Ref. No	Species	Est. Height (m)	Stem Dia. (mm)	Canopy Spread (m)				Crown Clearance (m)	Physiological Condition	Age	Structural Condition	Preliminary Management Recommendations	Est. Remaining Contribution (yrs)	Cat.
				N	S	E	W							
T8	English Oak (<i>Quercus robur</i>)	15.0+	580	1.7	7.9	9.5	3.2	3.0	Fair/Good	M	Growing on bank area on woodland edge and in competition with adjacent trees. Canopy bias to SE with long lateral limbs extending towards site. Large buttress roots exposed where soil has been progressively eroded from bank. Ivy becoming established on main trunk.	Of amenity/ecological value as part of woodland group. Sever/remove Ivy to lowest 1.0m of trunk and reassess. Remove dead wood only where this represents a Health and Safety hazard. Assess stability and consider reduction of long, lateral limbs to re-balance	40+	B2
T9	English Oak (<i>Quercus robur</i>)	15.0+	460	1.0	2.8	6.7	6.2	3.0	Fair	M	Growing on bank area on woodland edge and in competition with adjacent trees. Canopy bias to SE. Ivy becoming established on main trunk. Deadwood visible within canopy. Redundant barbed wire running past base of trunk	Of amenity/ecological value as part of woodland group. Sever/remove Ivy to lowest 1.0m of trunk and reassess. Remove dead wood only where this represents a Health and Safety hazard.	40+	B2

T10	English Oak (<i>Quercus robur</i>)	15.0+	900	4.7	6.4	7.1	8.6	4.0	Fair	M	Growing on bank area on woodland edge and in competition with adjacent trees. Canopy slightly bias to SE due to competition with adjacent trees. Deadwood within canopy. Large buttress roots/flaring at base	Of amenity/ecological value as part of woodland group. Sever/remove Ivy to lowest 1.0m of trunk and reassess. Remove dead wood only where this represents a Health and Safety hazard	40+	B2
G1	Under-storey with occasional larger English Oak (<i>Quercus robur</i>) inset - not surveyed, including; Rose (<i>Rosa sp.</i>), Barberry (<i>Berberis sp.</i>), Cotoneaster, Ivy (<i>Hedera helix</i>), Gorse (<i>Ulex europaeus</i>), Hawthorn (<i>Crataegus monogyna</i>), Hazel (<i>Corylus avellana</i>) and Buddlejia.										Oak to approx 15.0m Ht. Under-storey to 4.0m Ht. (Max). Generally dense and unmanaged			
G2	Woodland belt including; Mature English Oak, (<i>Quercus robur</i>), Semi-mature Sycamore (<i>Acer pseudoplatanus</i>), Wild Cherry (<i>Prunus avium</i>), Common Ash (<i>Fraxinus excelsior</i>). Understorey comprising of Hawthorn, (<i>Crataegus monogyna</i>), Blackthorn (<i>Prunus spinosa</i>), Elderberry (<i>Sambucus nigra</i>), Cotoneaster, Wild Privet (<i>Ligustrum vulgar</i>), Hazel (<i>Corylus avellana</i>)										Oaks to approx 15m+ Ht. Semi-mature trees to approx 10.0m+ Ht. Under-storey to 4.0m Ht. (Max) Locally dense with limited access to bank areas. Occasional former coppice stools visible but generally unmanaged.

Erosion of topsoil was evident on some bank areas and in particular around the buttress roots of trees, which could lead to longer term instability of trees, especially those leaning to the south-east. Exposed bedrock was visible in several locations and it is possible that topsoil depths may vary considerably through the area. As a result, the stated root protection areas around each tree are likely to be distorted according to the depth/availability of suitable growing medium. This may also compound the above stability issues.

Site construction will involve the removal of T1, T2 and G1 in order to form a new built structure and adjacent parking provision. The retention of T3 within the new 'break-

The existing boundary line appears to be maintained for the portion of development site bounding the woodland, however the RPA of T4, T5 and T10 appear to encroach into the site, (notwithstanding the unknown factor shallow bedrock and topsoil may have on root distribution). However, since these areas fall within proposed soft landscaped areas, if the existing ground levels can be maintained and minimal ground disturbance occurs it should be possible to protect the RPA of these trees.

T5 and T8 appear to have canopy spreads which extend over the current site boundary to the south-east and into the site. Depending upon the nature of site operations or boundary/security fencing requirements, it may be necessary to locally reduce the canopy spread of these trees on the south-east side to prevent mechanical damage. Additionally, further assessment of the stability of the surveyed trees bounding the site, (as recommended) may require the canopy reduction of further trees which should help to minimise the instance of premature failure.
